Technical Note N-515

EVALUATION OF A HYDRO-PNEUMATIC FLOATING FENDER OR CAMEL

June 1963

U. S. NAVAL CIVIL ENGINEERING LABORATORY  
Port Hueneme, California

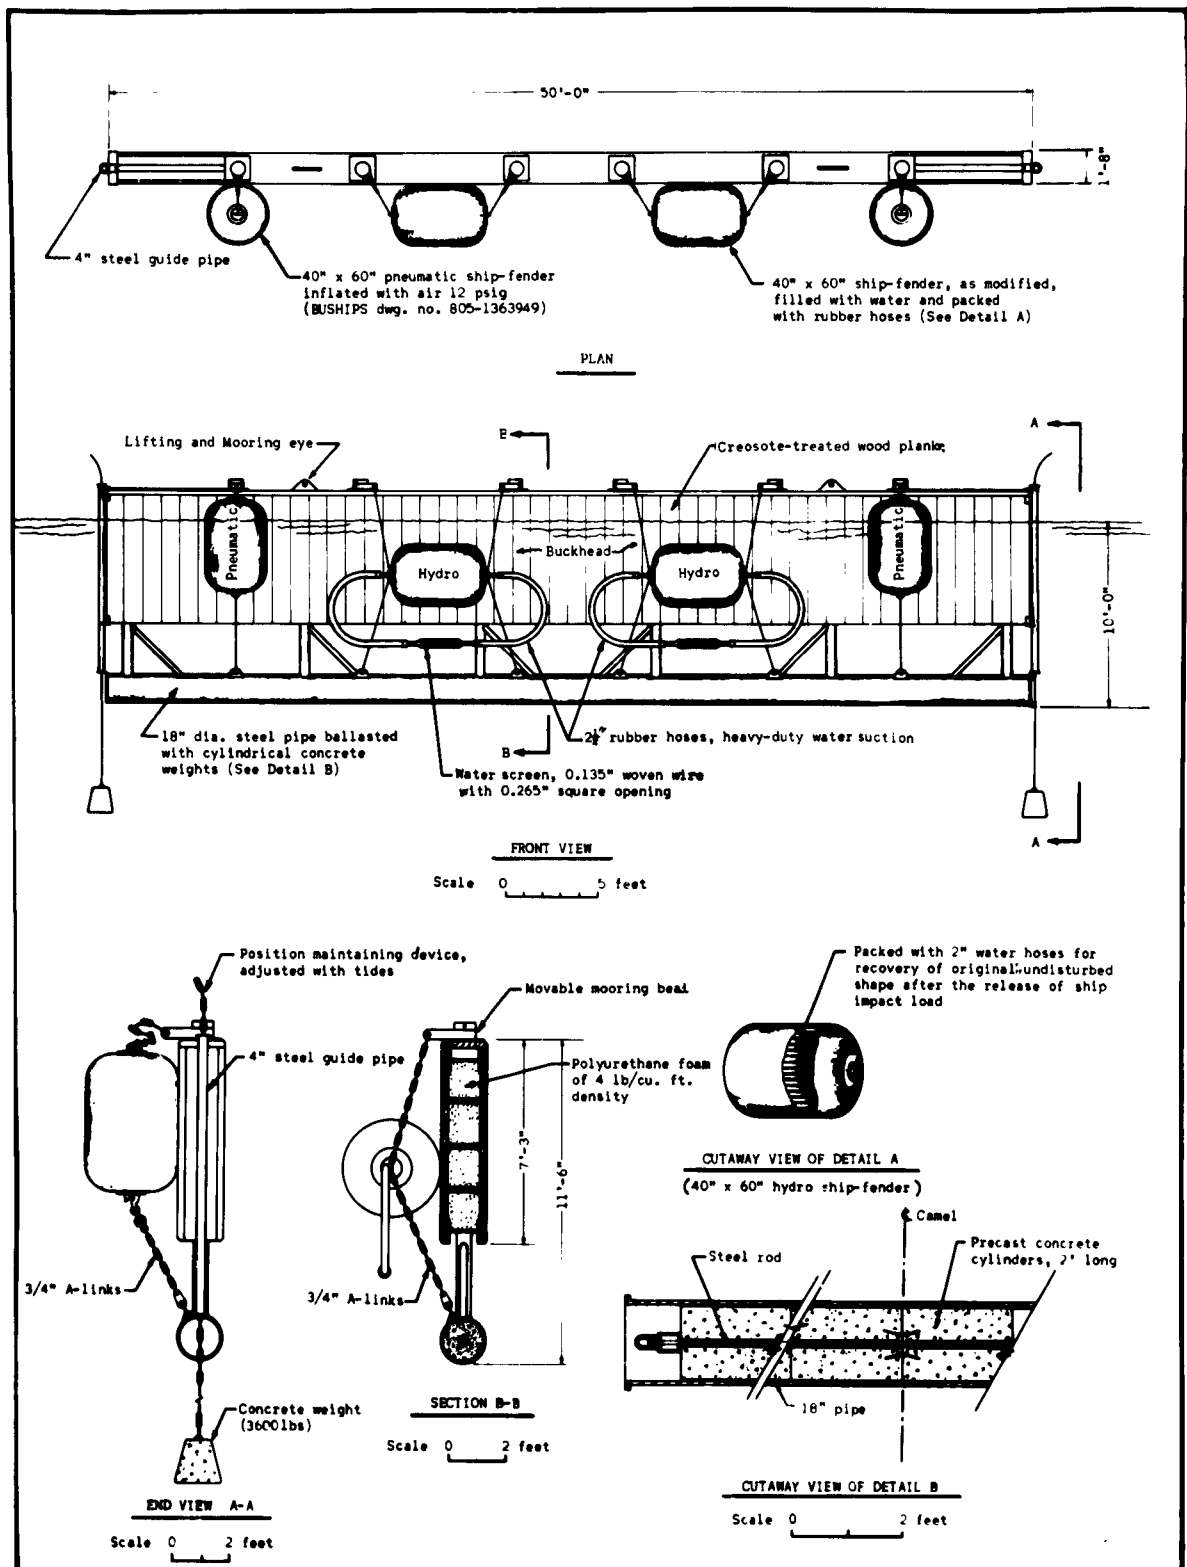
Figure 1 Hydro-pneumatic Energy Absorbing Camel

The basic element in the BUDOCKS-designed NCEL-tested camel is a 50-foot long, 1'8" wide, 11'6" high floating bulkhead (Figure 1). The bulkhead is protected by two 40" x 60" pneumatic rubber ship-fenders with a minimum 6.6 psig or higher, up to 24 psig, initial air pressure, and two similar fenders filled with water. These rubber cushion units have a total minimum energy-absorbing capacity of 20 foot-tons and a maximum of 86 ft-tons. However, in practice, only a few rubber fenders make contact with the ship; therefore, even the minimum total energy-absorption capacity is not utilized. For recovery purposes, the water-filled fenders are packed with rubber hoses which serve to spring the fenders back to their undisturbed shape after the ship's load is removed. They are secured to the bulkhead with their axis horizontally instead of vertically as for the pneumatic fenders. An 18" pipe filled with sectional concrete cylinders is used as ballast weights.

The camel has two lifting and mooring eyes located approximately 10 feet from each end. In addition, a position maintaining device, not in the original design, was provided (Figure 1). The energy-absorbing characteristics of both hydro and pneumatic fenders are shown in Figures 2 and 3. It will be noted that each hydro-fender will absorb a maximum energy of 25 ft-tons as compared with 18 ft-tons (initial air pressure 24 lb/in<sup>2</sup>) for pneumatic fenders, assuming in both cases maximum pressure of 50 lb/in<sup>2</sup> which is the working strength of the rubber fenders. The impact load will not exceed a maximum allowable load of 40 tons on the ship's hull. Naval architectural characteristics are shown in Table I.

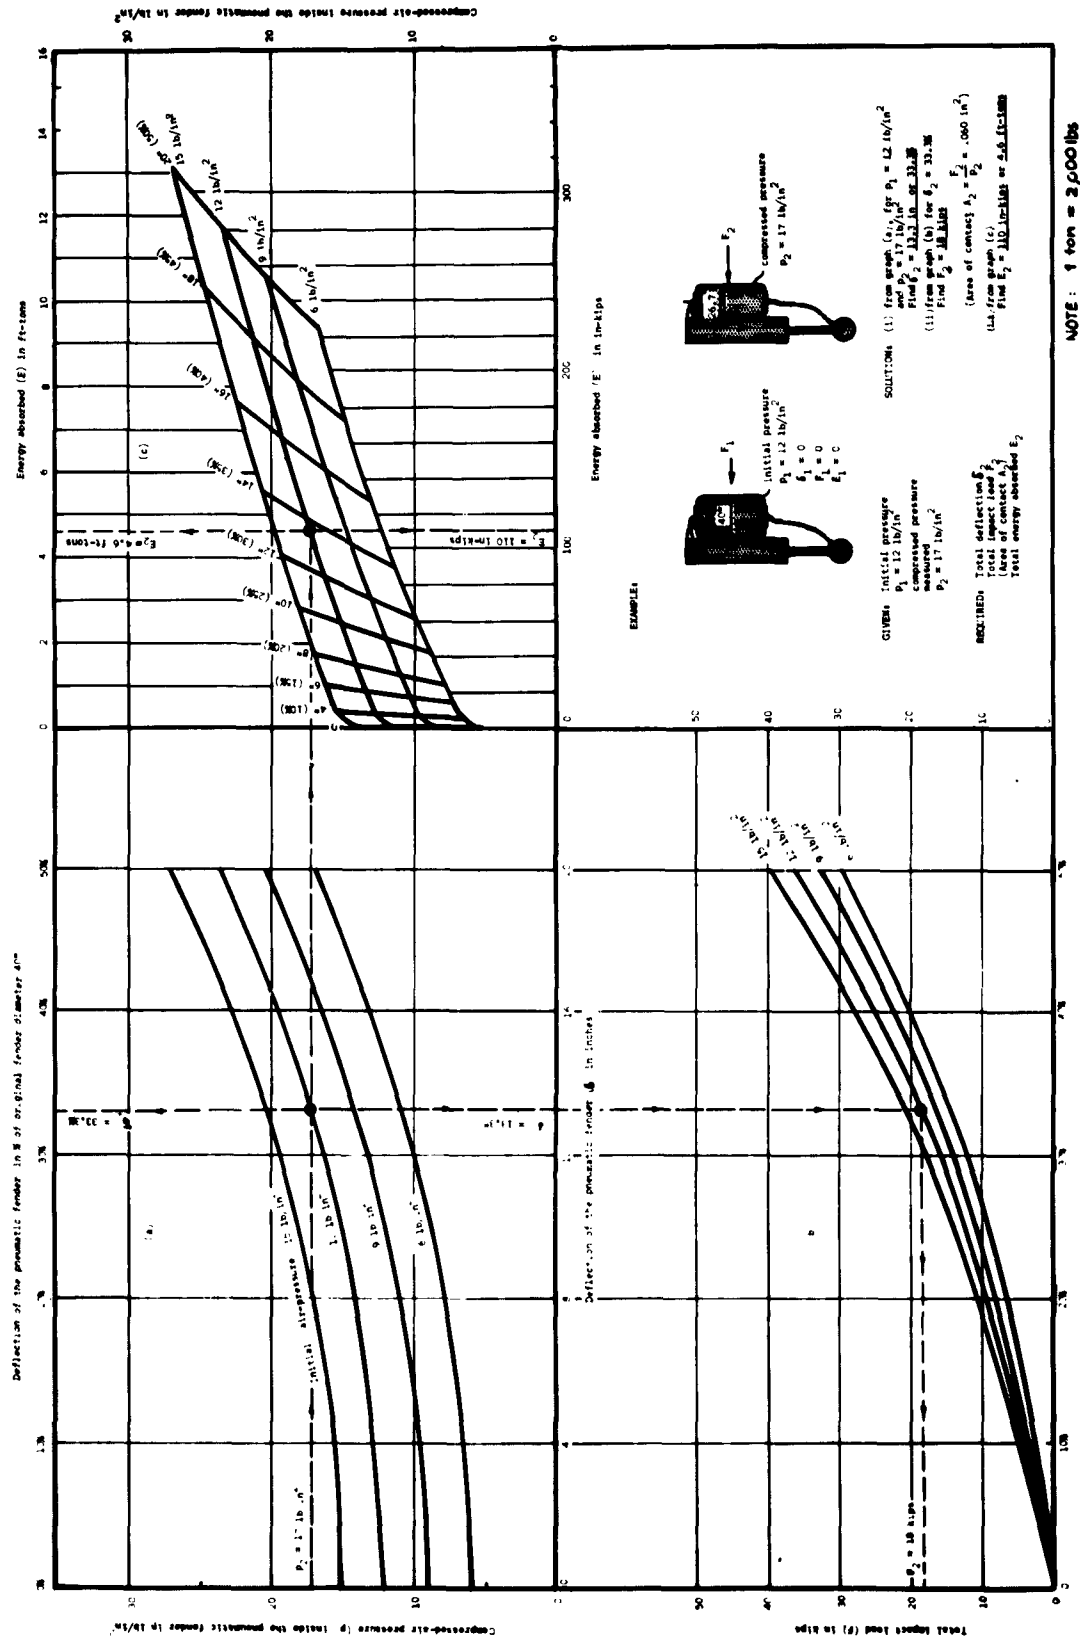
Figure 2 Energy Absorbing Characteristics of Pneumatic Rubber Ship-fender

The energy absorbed by each of the pneumatic fenders is determined from measurements of the pressure exerted on each rubber fender. These, in turn, give the load-deflection history during impact. A sample calculation is provided in Figure 2. An air-pressure transducer in a water-proof housing is provided for each pneumatic fender. A special fitting serves to transmit the pressure to the pickup as well as to inflate the rubber fender.

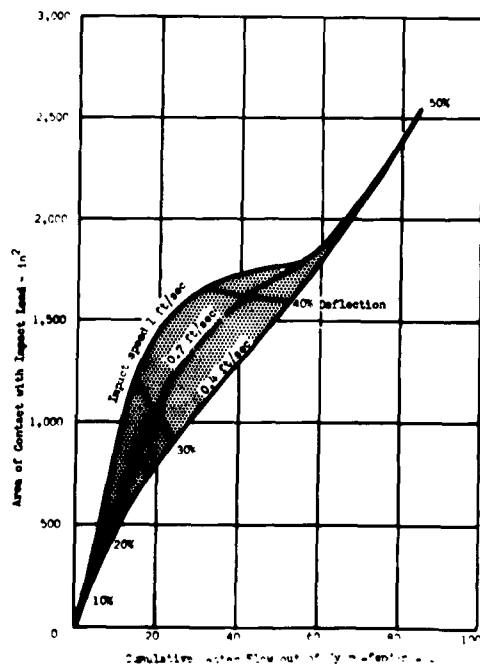
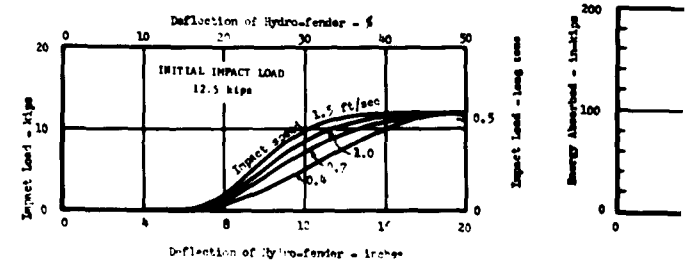
Figure 3. Energy-Absorbing Hydro Rubber S

(a) Pressure - Water Flow Relationship

(b) Water Flow - Deflection Relationship

(c) Deflection - Contact Area Relationship

(d) Load - Deflection Characteristics (Initial Impact Load = 50 kips)

(e) Load - Deflection Characteristics (Initial Impact Load = 22 kips)

(f) Load - Deflection Characteristics (Initial Impact Load = 12.5 kips)

(j) Energy - Absorbing Characteristics of a 40" x 60" Hydro Ship-Fender

The energy absorbed by each of the four water-filled rubber fenders is determined from load deflection characteristics (Figure 3) inferred from pressure measurements. The area of contact and deflection are related to the rate of flow by a calibration in which the discharge through the connecting tubes is directly related to the pressure measured.

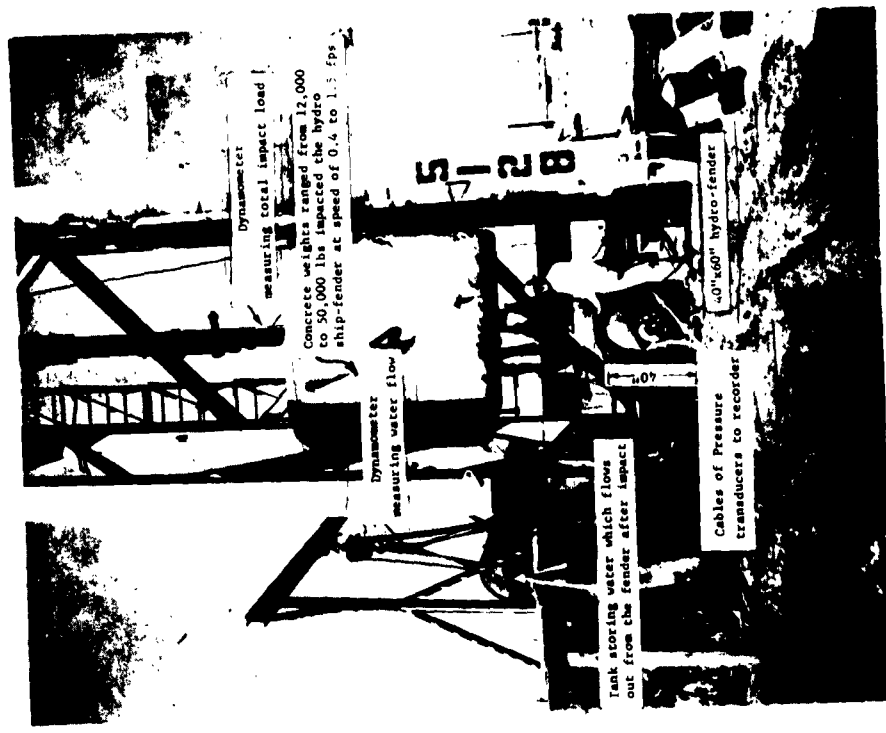
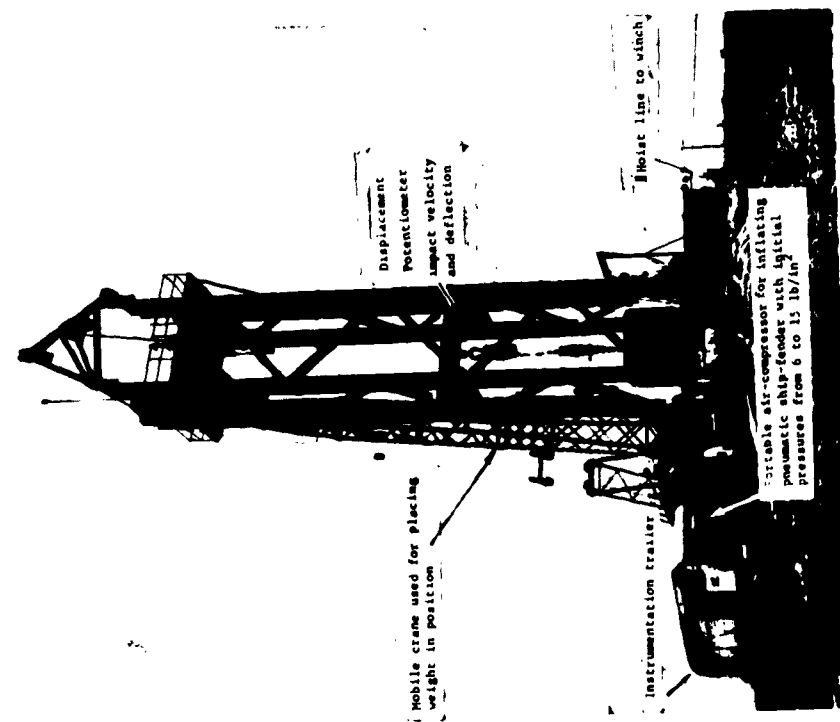
(b) Concrete weight being elevated ready for testing of hydro and pneumatic rubber ship-fenders

(a) Long-pile testing tower used for calibrating

Figure 5 Testing Facilities Used for Calibrating Both Hydro and Pneumatic Rubber Ship-fenders (See also Figure 6)

Calibration was done using a pile testing facility (Hromadik, 1961<sup>5</sup> and Figures 5 and 6). Three loads ranged from 12,500 to 50,000 lbs were applied at speeds of from 0.4 to 1.5 feet per second.

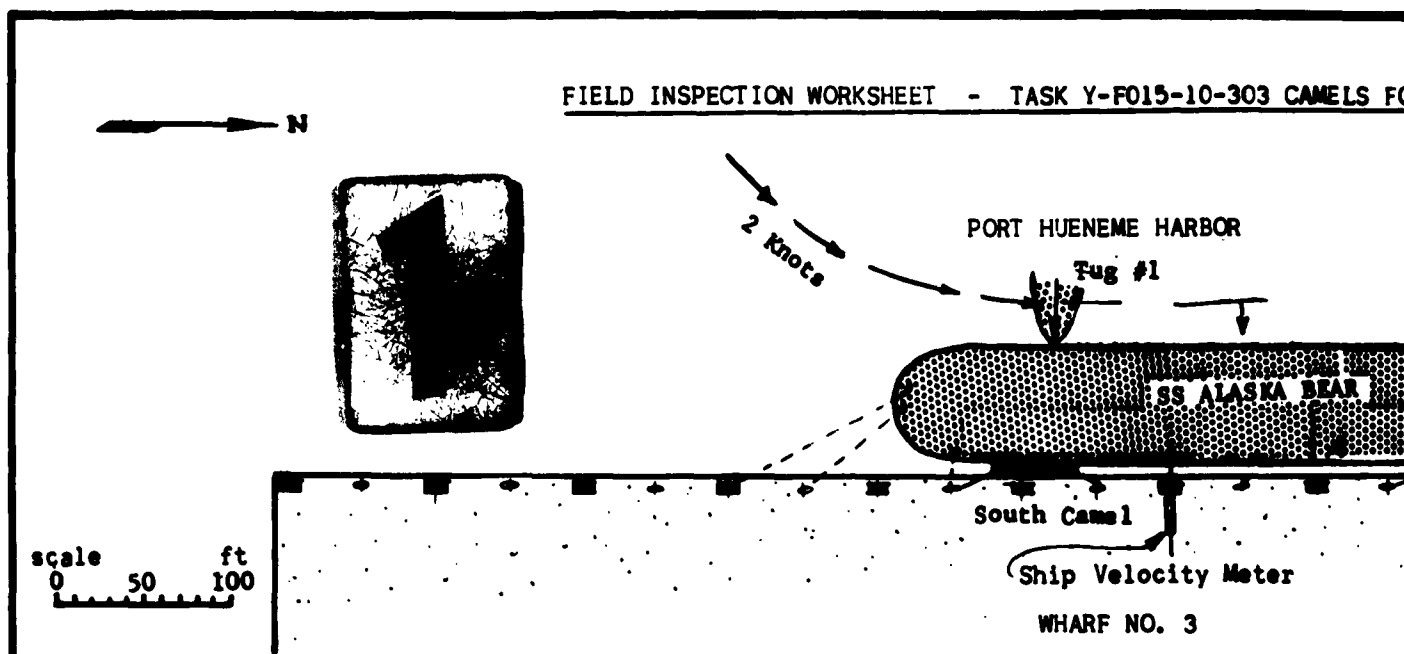
Figure 7 A Sample Field Inspection Worksheet

ENVIRONMENT		BERTHING SHIP CHARACTERISTICS	
<p><u>Wind:</u> Speed 6mph Direction: 20-25°</p> <p><u>Wave:</u> <input checked="" type="checkbox"/> Calm <input type="checkbox"/> Moderate <input type="checkbox"/> Rough</p> <p><u>Current:</u> <input type="checkbox"/> Yes <input checked="" type="checkbox"/> No</p> <p><u>Tug-made Wave:</u> <input type="checkbox"/> Yes <input checked="" type="checkbox"/> No</p> <p>Tug speed: - knots</p> <p>Angle of approach - degrees</p> <p><u>Small:</u> <input type="checkbox"/> Yes <input checked="" type="checkbox"/> No</p> <p><u>Tide:</u> <input type="checkbox"/> High Gage +2 ft</p> <p><input type="checkbox"/> Mean</p> <p><input checked="" type="checkbox"/> Low</p>		<p><u>Names:</u> Ship: <u>Alaska Bear</u> Captain <u>David L.</u></p> <p><u>Type:</u> Pacific Far East Line, Inc.</p> <p><u>Displacement:</u> Full <u>15,200</u> tons</p> <p>Berthing <u>8200</u> tons</p> <p><u>Length:</u> 455' 3"</p> <p><u>Beam:</u> 62'</p> <p><u>Draft:</u> Bow <u>10.5</u> ; Stern <u>22.5</u></p> <p>Mid-draft 28'6 3/4" (full)</p>

GENERAL COMMENTS	SHIP CAPTAIN	<p>(1) The distance between the dock and ship berthed is considered too far but this would be satisfactory if the cargo ship is too far away from dock for satisfactory</p> <p>(2) The normal boom capacities ranged from 5 tons to 50 tons for large boom. Small booms are not adequate for large cargo ships.</p> <p>(3) The simple-log camel is considered adequate for most merchant ships. There is no problem with the simple-log camel.</p> <p>(4) The high-pressure inside the rubber fenders might dent the ships hull.</p> <p>(5) It will be possible to break the bags by pin-pointing and longitudinal forces, (observed).</p> <p>(6) The test camels have the advantage of distributing impact load to fender piles but the simple-log camel is considered adequate for most merchant ships.</p> <p>(7) Consideration should be given to securing the rubber fenders directly to the fender piles.</p>

PILOT AND OTHERS	<p>Capt. Fosse commented: (1) The cargo ship is too far away from dock for satisfactory</p> <p>(2) The rubber fenders will be subjected to tearing loose by barges</p> <p>(3) The half-pipes welded on ship-hull (from scupper to the bow) are not adequate</p> <p>(4) The test camels would work well in large harbor basins.</p> <p>Capt. Swanson commented: (1) There is a law that the maximum distance between dock and ship is 100 feet</p> <p>(2) Rubber tubes hanging on fender piles would be better than the simple-log camel.</p>	
	SUMMARY	<p>Capt. Parker is very cooperative, and pleasant to work with. It seems that the berthing was very careful. No wave and inertia impact observed. Only four bags of cement were used.</p>

A sample Field Inspection Worksheet completed for "SS Alaska Bear" is shown in Figure 7.

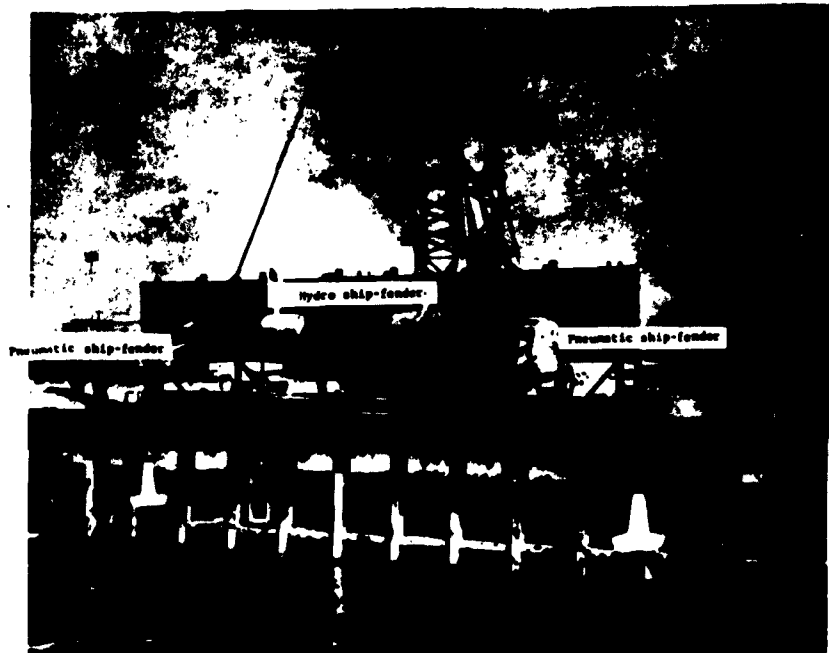
(a) A Single-log Camel Being Removed

(b) A Hydro-pneumatic Camel Being Installed

Figure 8 Installation and Operation of a Hydro-pneumatic Camel at Wharf No. 3, Port Hueneme Harbor, Calif. (See also Figure 9)

Two camels were fabricated at NCEL and installed on March 8, 1963 at Wharf No. 3 of the Port Hueneme Harbor, using a mobile crane, with a clear spacing of approximately 100 feet. Figures 8 and 9 show the camels during installation and operation, respectively. Figure 10

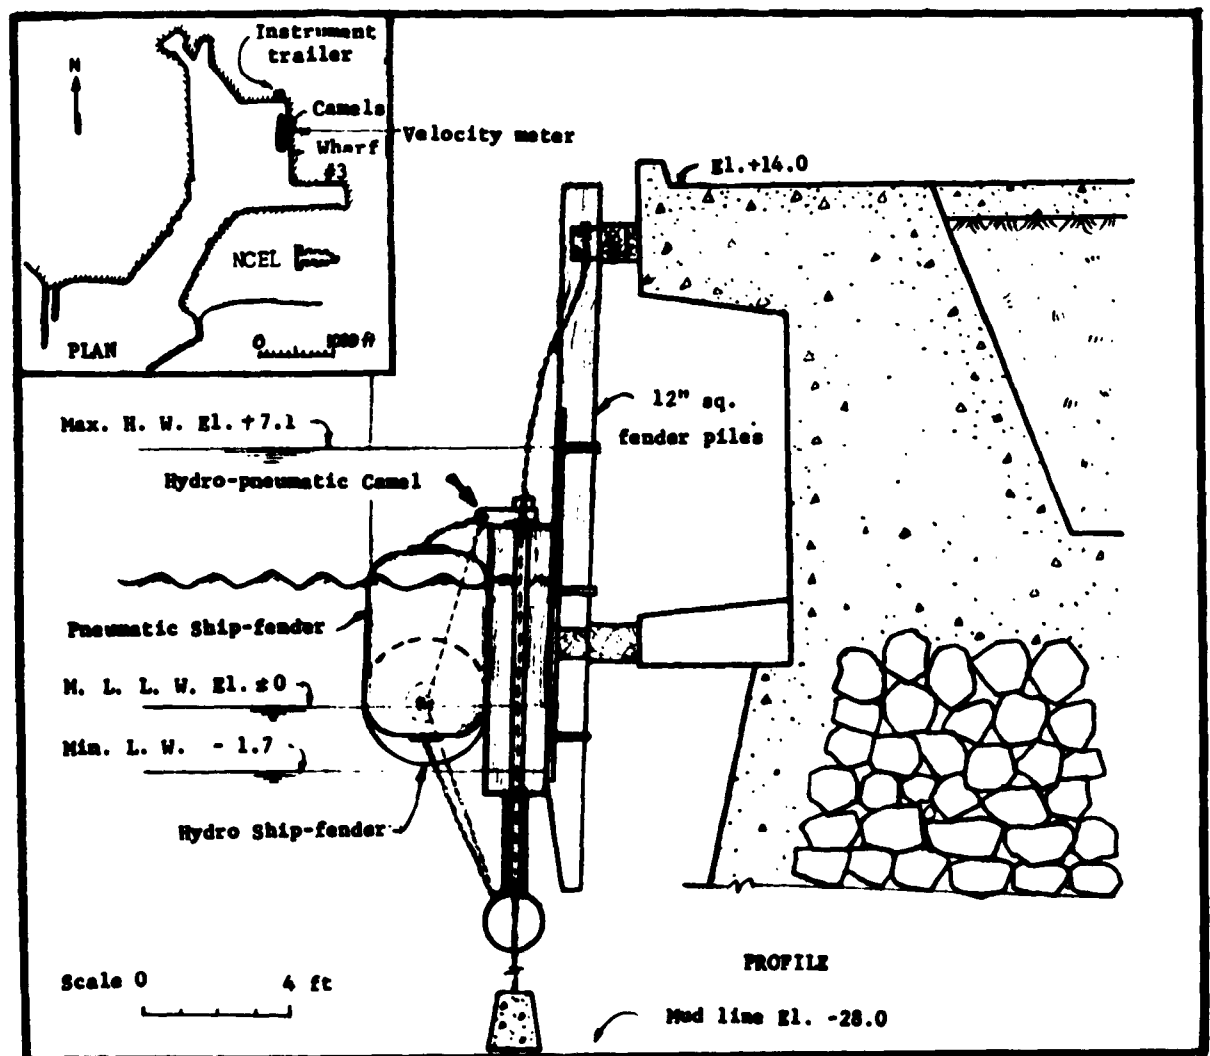
Figure 10 General Plan and Profile of the Test Site -  
Wharf No. 3, Port Hueneme Harbor, California

shows the general plan and profile at the test site.

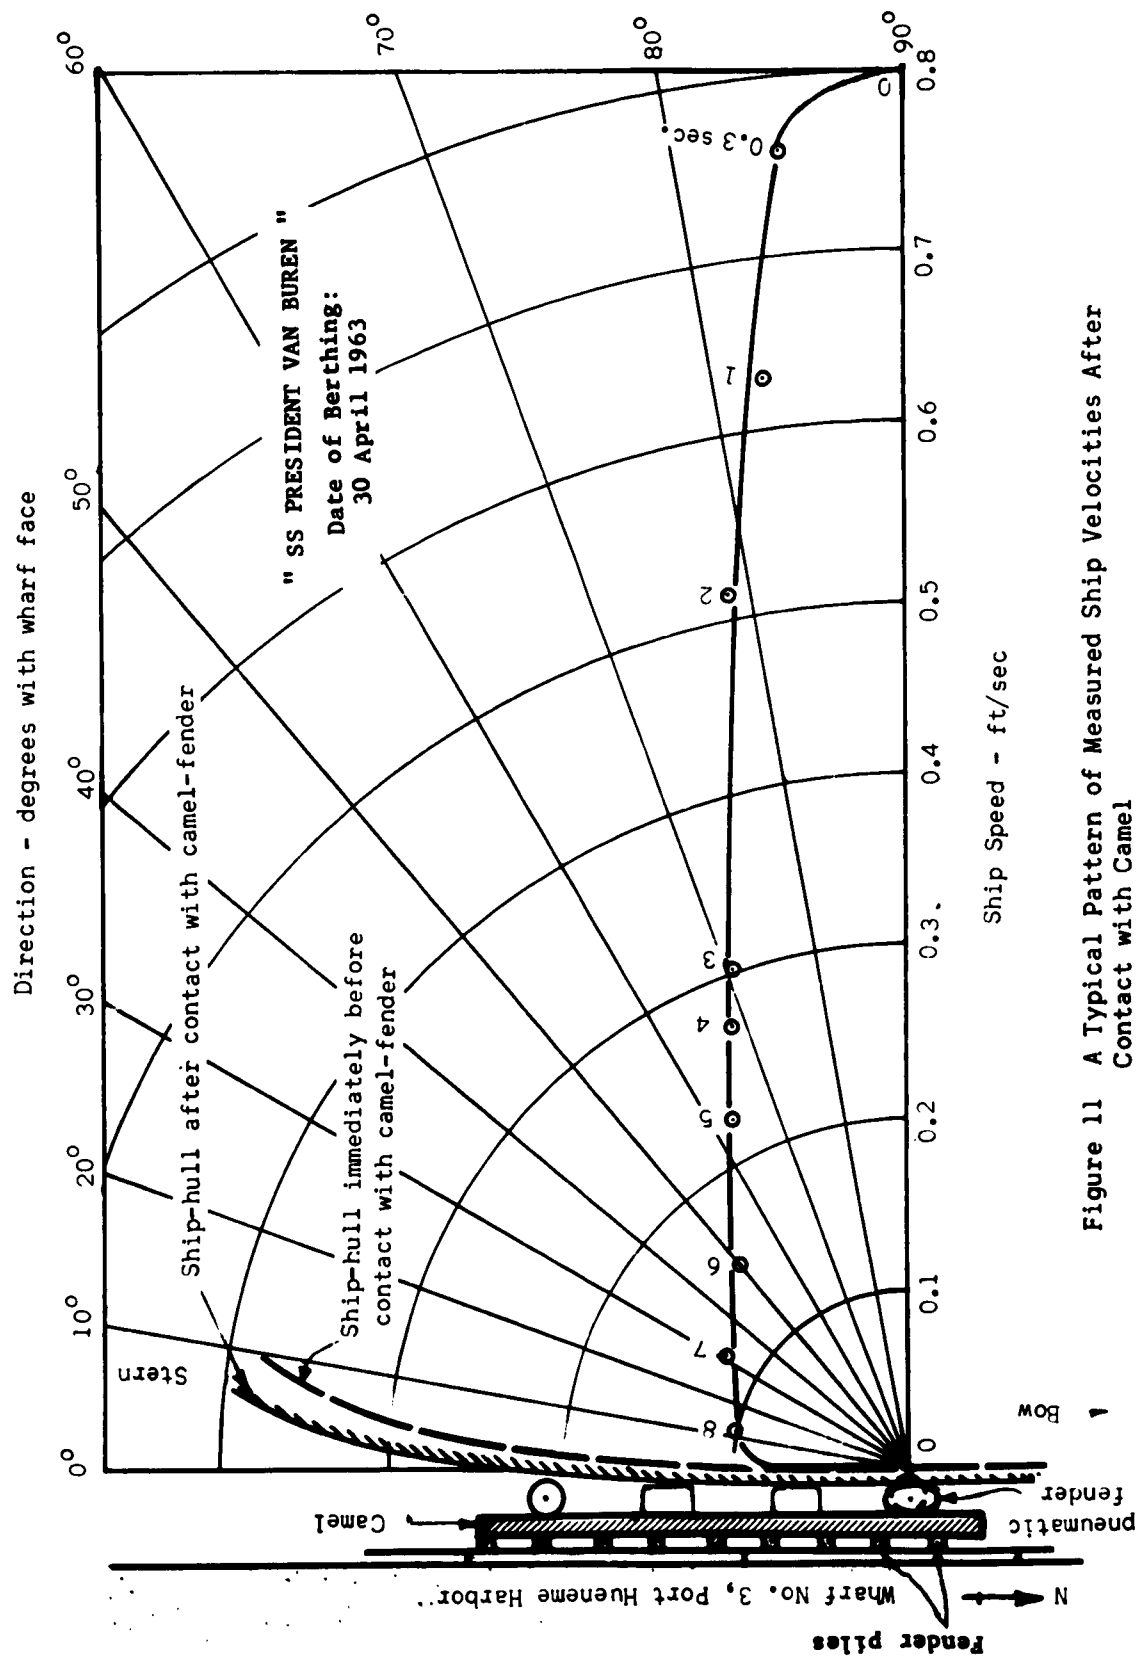
Figure 11 A Typical Pattern of Measured Ship Velocities After Contact with Camel

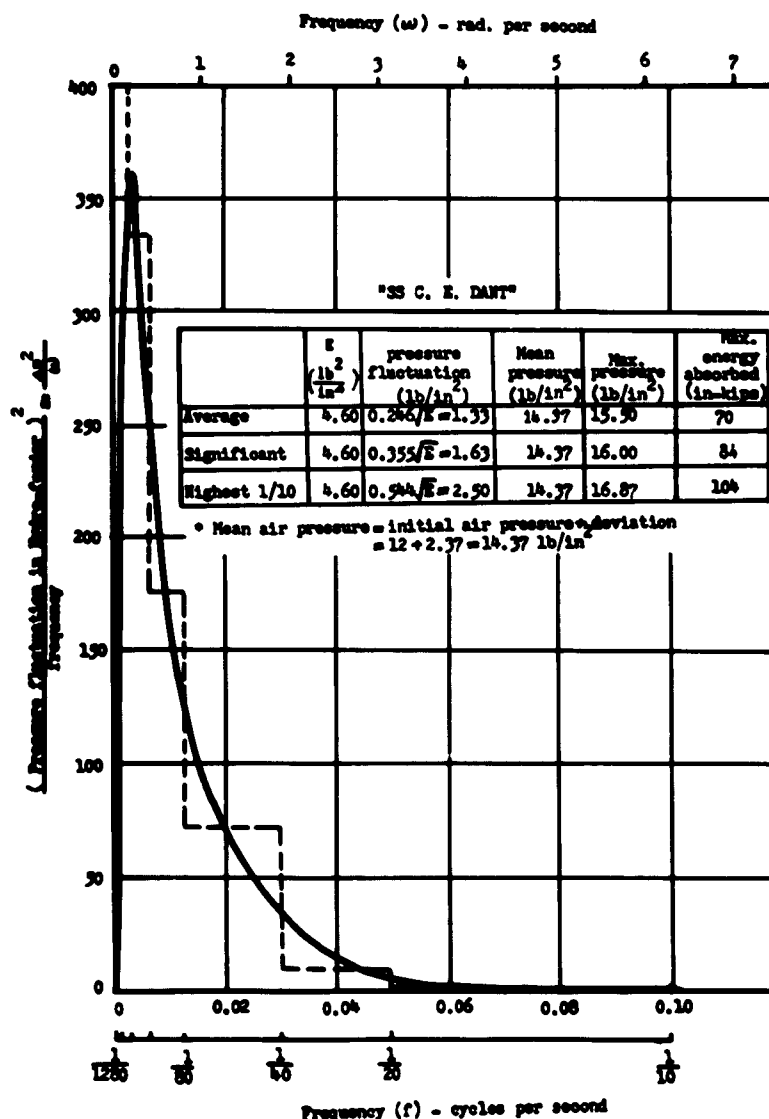
(a) Pressure Fluctuations Recorded

(b) Frequency Analysis

Figure 14 A Sample Spectral Analysis of Measured Pressures of a Pneumatic Fender.

(c) Power Spectrum

The total load exerted by the rubber fenders was computed indirectly from the pressures measured. It varied from 4.2 to 24.6 long tons. The total kinetic energy absorbed was obtained from the summation of the energy absorbed by each individual rubber fender in contact with the berthing ship. It varied from 1.5 to 17 ft-tons which is from 4% to 42% of minimum designed capacity of the two camels. The energy-absorbing data is shown in Table II and Figure 15. A sample spectral analysis of measured pressures was made and the significant, average and highest one-tenth of energies absorbed were determined accordingly (Figure 14).

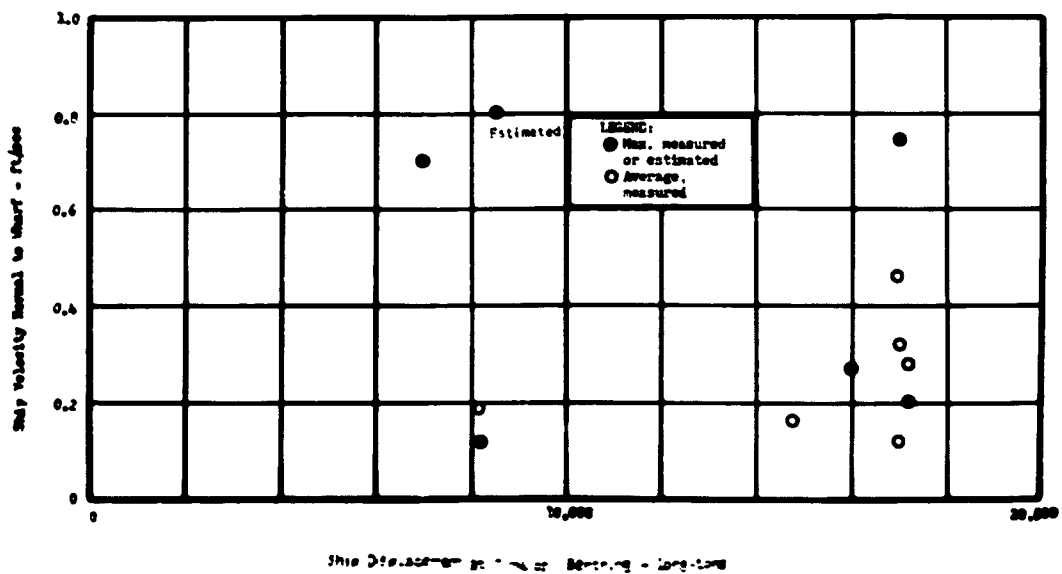
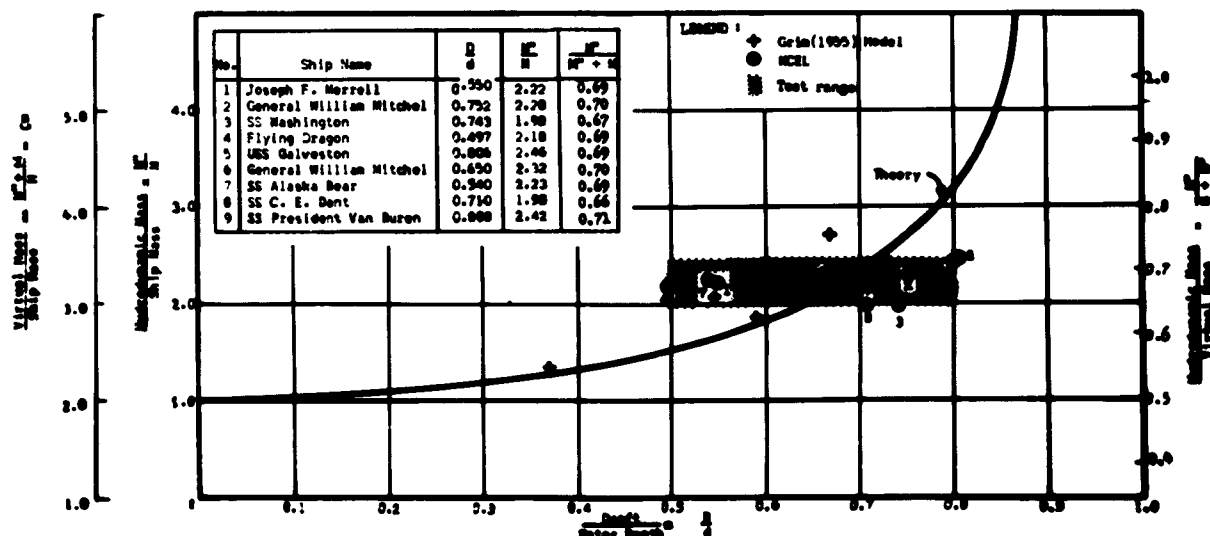
(a) Typical Recording of Field Measurements -  
"USS General William Mitchell", 18 April 1963

(b) Ship Velocity Component Normal to Wharf

(c) Impact Load and Energy Absorption

Figure 15 Summary of Results of Load Measurement and Inspection Program.

(d) Hydrodynamic Masses

Hydrodynamic masses and kinetic energy were computed using measured ship velocity, acceleration, and the known ship characteristics. The hydrodynamic mass varied from 2.98 to 3.46 times the ship's mass (Figure 15). The kinetic energy generated by the berthing ship varied from 3 to 73 ft-tons.
